STRUCTURE INSPECTION

SCOPE OF THE STRUCTURAL INSPECTION: 266CMR: BOARD OF REGISTRATION OF HOME INSPECTORS

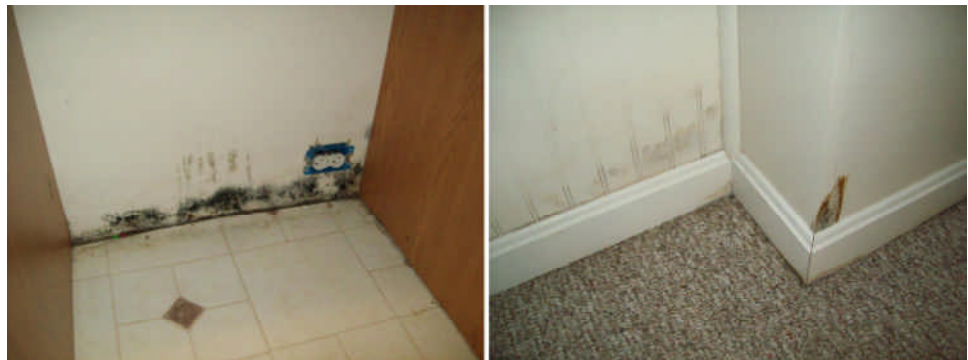
Observation: Suspected mold was visible in the home.

Analysis: **DISCLAIMER: THE INSPECTION AND REPORTING ON MOLD IS EXCLUDED FROM THE INSPECTION AND REPORT PER OUR AGREED CONTRACT. Mold detection and investigation are beyond the scope of this limited visual home inspection and report. Any reference to mold is done so as a courtesy, without consideration, so that you can consult other experts.**

WARNING: Excessive mold can be a health concern and an irritant to those with respiratory problems. Be advised that many homes have excessive moisture and poor ventilation issues which might lead to mold, and that the extent of mold beyond visible surfaces is undetermined. There is a possibility of concealed problems. Therefore, further investigation is needed as mold abatement can quickly involve significant expense.

Recommendation: I advise that you hire a microbiology laboratory **NOW** to perform a comprehensive investigation including collection and analysis of indoor air and surface mold samples, full report and discussion of qualitative and quantitative results, and suggestions concerning remediation before close of escrow. Be advised that testing may confirm a need to hire a professional environmental company to perform

remediation at **significant expense**.

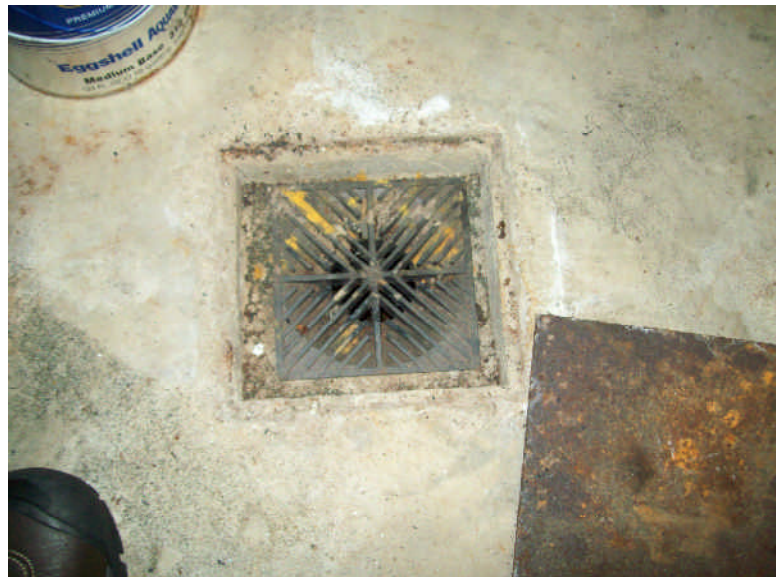
Observation: There is a floor drain present in the basement floor.

Analysis: The true function, seasonal need and discharge point of the drain are undetermined.

Recommendation: Ask the owner where the drain discharges and how often it is needed. (Cleaning & testing for drainage is advised.)

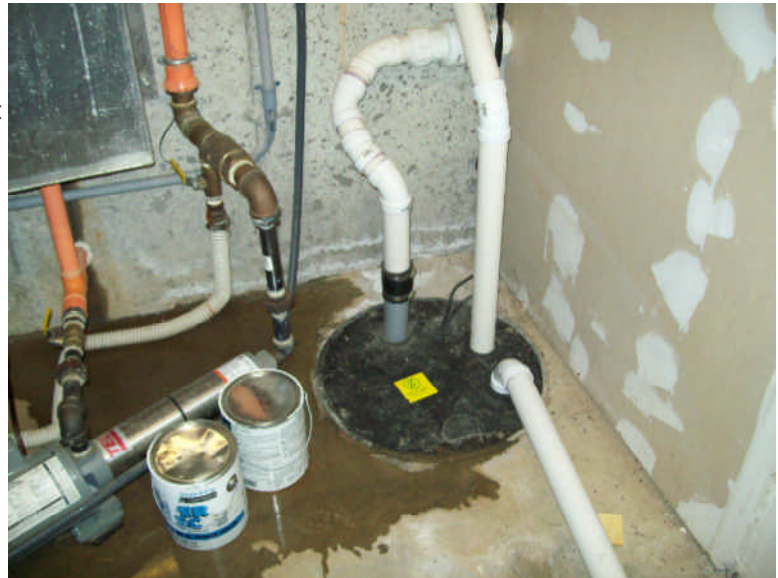
Observation: No sump pump in the *readily accessible* parts of the basement at time of inspection. But the home does have a sewage ejection pump. This collects the sewage, grinds it up and sends it out to the septic system.

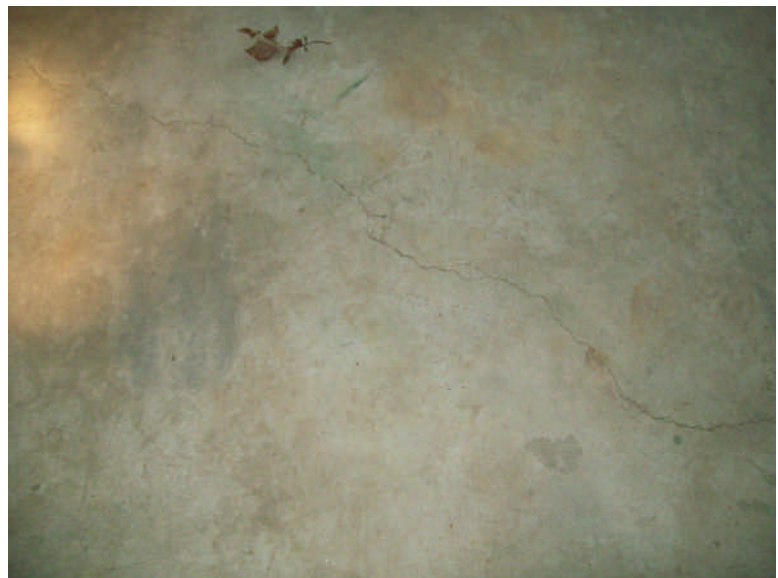
CONCRETE where exposed. (Note: The inspector is not required to move storage or floor coverings to examine the basement floor. There is a risk of concealed damage, shrinkage cracks, cold joint separations or hidden water stains behind the storage or finished surfaces). Non-critical small random cracks are present in the basement floor.

Observation: Some of the basement floor system is concealed by finished floor coverings.

Analysis: As the basement floor system is not *readily accessible*, true conditions are

undetermined. Be advised that removal of floor coverings may reveal problems that are not documented in this report.

Recommendation: If you have concerns regarding hidden problems, then you should ask if the floor covering can be removed for further investigation.

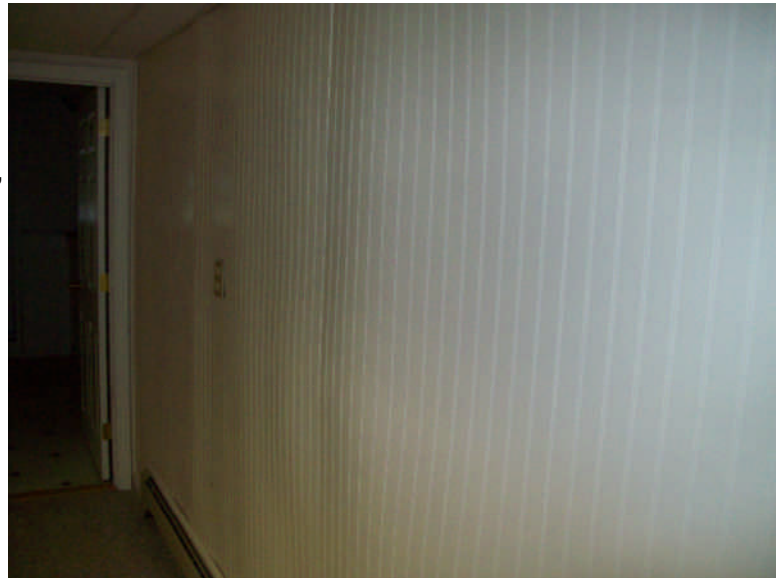
Observation: In the basement there is a finished room with paneling installed that is poorly done.

Analysis: As we could see the wall is very wavy. It is possible moisture absorbed into the paneling to cause this when they had the leaks in the plumbing. Or it could be just poorly installed from the beginning.

Recommendation: I would remove the paneling for further inspection behind then make any corrections and reinstall new paneling.

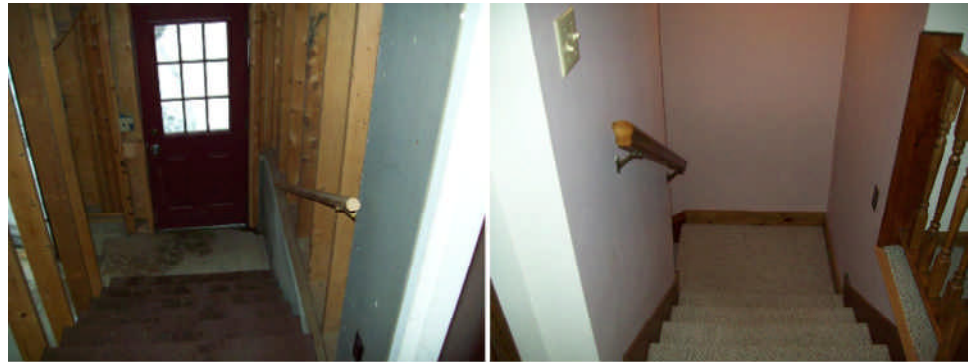
Observation: The staircase to the basement and second floor lacks returns at each end of the handrail.

Analysis: **** **UNSAFE**. A return is a short piece of handrail intended to prevent someone from hooking a handbag or pocket on the end of the railing and tripping or falling and suffering a personal injury. While the old staircase handrail may be pre-existing, **URGENT** safety upgrading is advised.

Recommendation: Hire a finish carpenter to correct the handrail in accordance with the requirements of the building code.
