Seacoast Inspections LLC
263 Winnacunnet Rd,
Hampton, NH 03842
603-783-1679

FINAL NARRATIVE REPORT

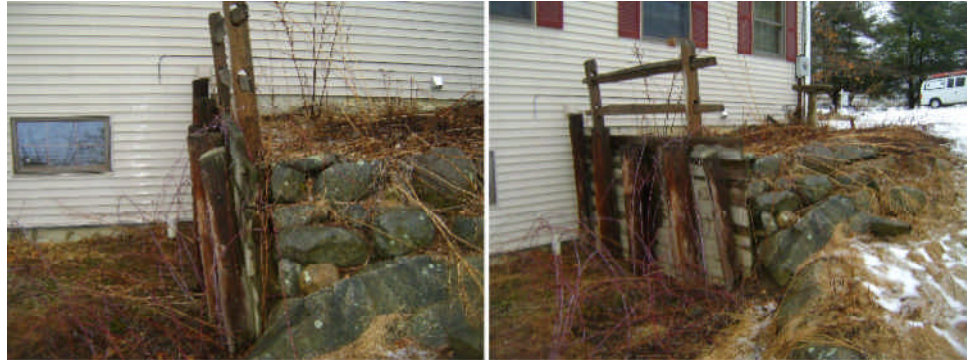
**RETAINING
WALL
PROBLEMS:**

Observation: The retaining wall has failed.

Analysis: When retaining walls fail, the problem is usually caused by problems with "the base preparation, drainage or reinforcement." Significant retaining wall reconstruction expenses are anticipated as the wall has reached the end of its service life or is *fully depreciated*.

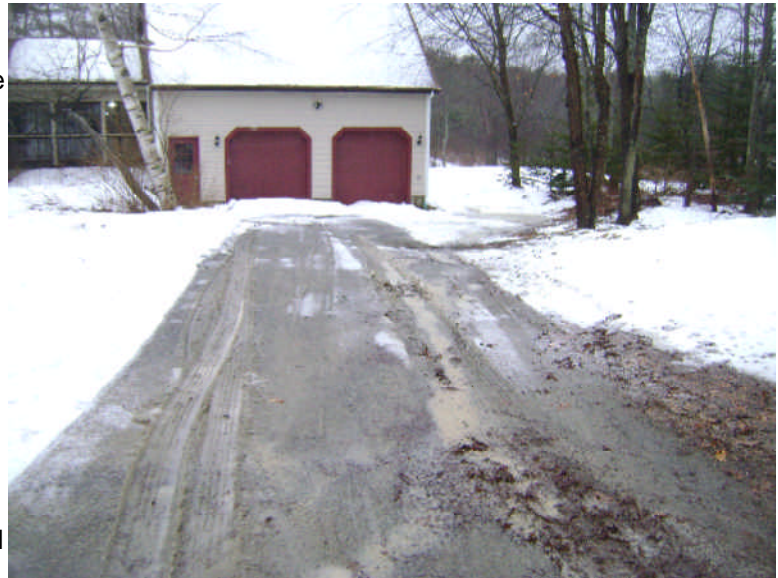
Observation: There was snow cover on the driveway at time of inspection.

Analysis: True conditions are undetermined. Note: There is a potential for concealed damage.

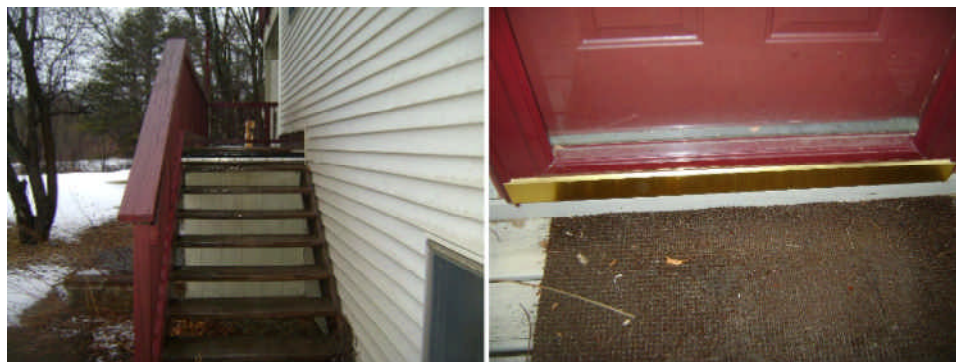
VISIBLE PROBLEMS WITH ENTRANCE COMPONENTS:

Observation: The handrail is not graspable.

Analysis: ***** UNSAFE - there is a risk of personal injury.** Handrails built of dimensional lumber (2 x 4 or 2 x 6) are not graspable. A graspable handrail is required at one side of a staircase. A staircase is part of the means of egress from the dwelling and must be maintained in a safe condition. **Urgent** repair is needed.

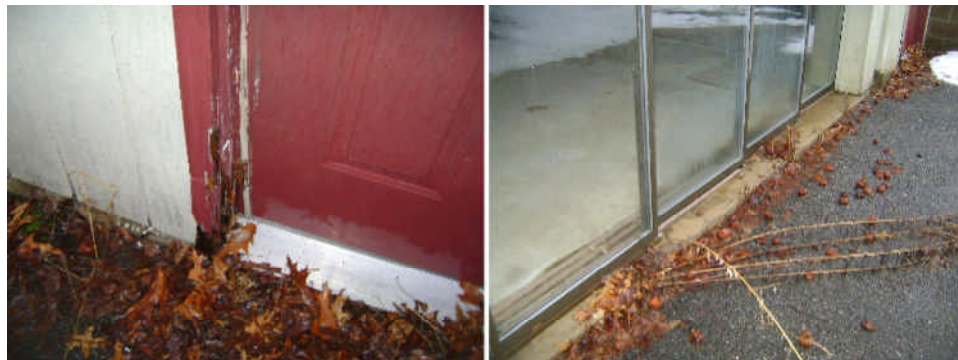
**BASEMENT
ENTRANCE
PROBLEMS:**

Observation: The door jambs at the exterior door are rotted out at the basement entrance.

Analysis: Door jambs at basement entrances are repeatedly wet and suffer from decay and/or pest infestation. Repair is needed. Note: There is a potential for concealed damage.

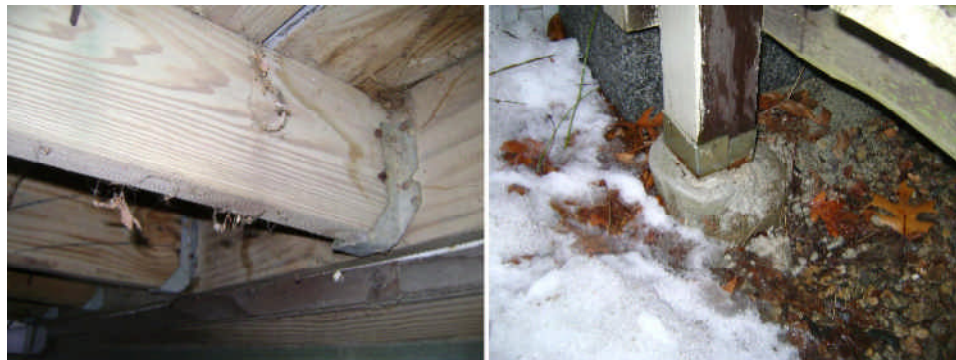
**VISIBLE DECK/
BALCONY
PROBLEMS:**

Observation: Inspection of the front covered entrance revealed the following defects that need repair or upgrading:

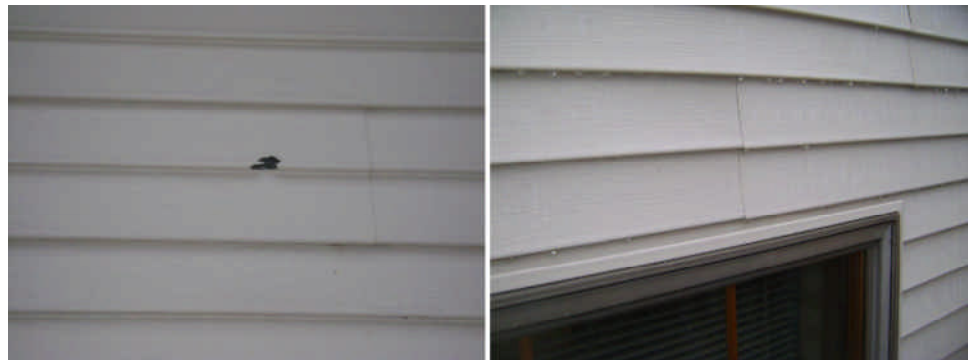
SIDING PROBLEMS:

Observation: Areas of joints where the siding meets windows, trim and doors are not caulked tightly.

Analysis: Missing or aged caulking can allow water infiltration, heat loss and decay.

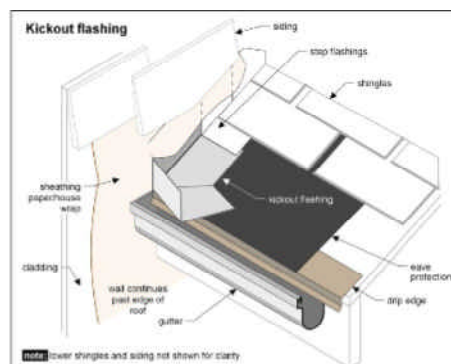
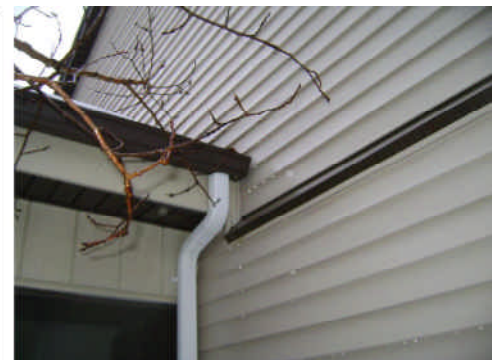
Observation: The joint between the stoop and the house siding does not appear to be flashed.

Analysis: This is conducive for decay or pest infestation as moisture will enter the space behind the staircase. The builder should have installed lead or aluminum flashing beneath then siding with a bend and lap resting upon the landing to shed water from the joint. Repair is needed.

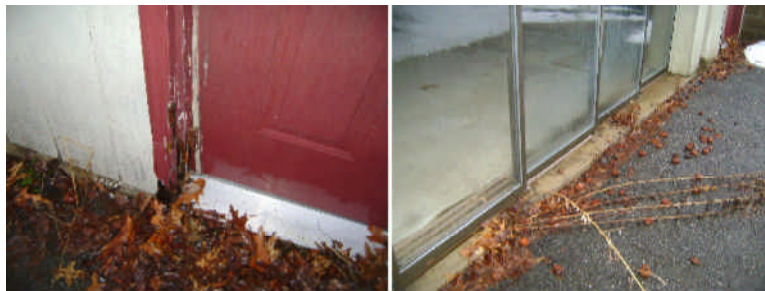
An exterior door jamb is damaged, cracked or broken - repair is needed.
Constant wetting has decayed the jamb and trim.

Analysis: In my opinion, the exterior door is at END OF SERVICE LIFE or is *fully depreciated*. Replacement is advised for safety.

Recommendation: Contact a tradesman relative to this area of concern and request reappraisal and cost estimation for replacement.

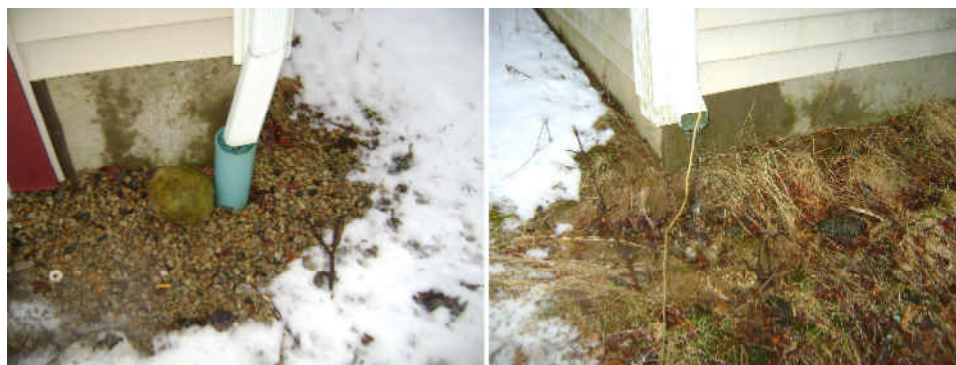
**GUTTER &
LEADER
PROBLEMS:**

Observation: The downspouts empty roof run-off water near or adjacent to the foundation.

Analysis: Dumping excessive water near the home may cause wet basement problems, foundation problems or soil erosion. Drainage control repairs are needed NOW.

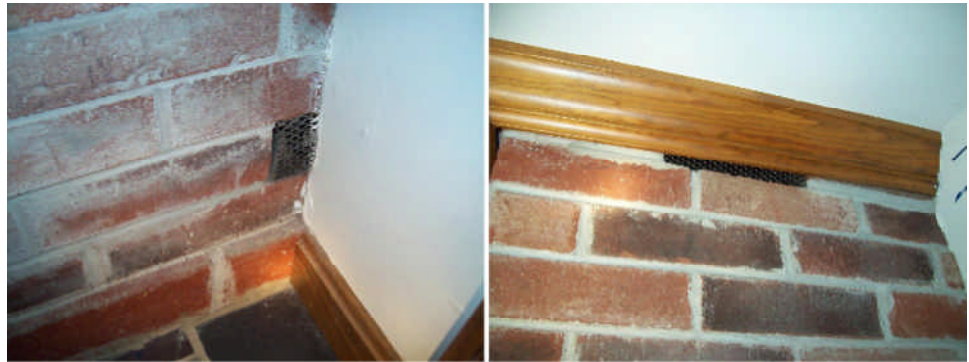
Additional problems:

Observation: Unplugged openings are present in chimney. In the basement the insulation is not an appropriate means to plug a flue. Also in the first floor there are what appear to be vents in the brick work.

Analysis: The concern is if the flues or brick wythe have been damaged by moisture poisonous combustion gases can enter the home and cause personal injury FIRE. **** UNSAFE

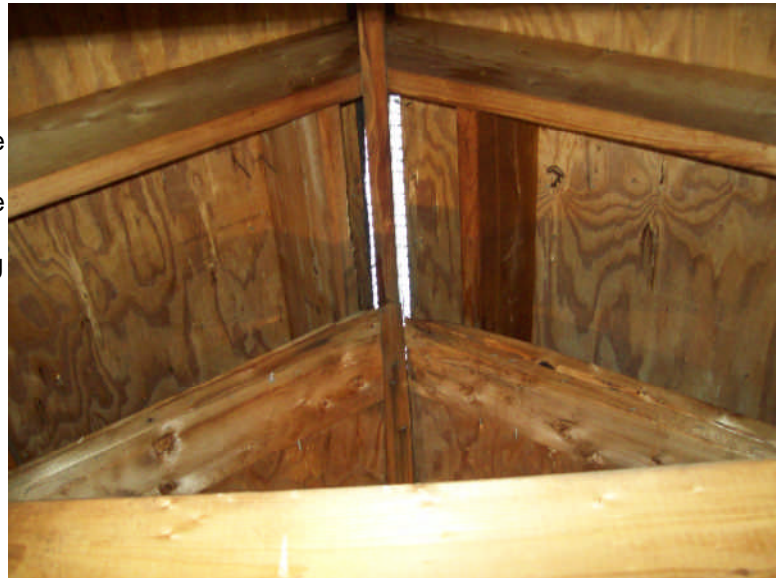
Observation: Due to the condition of the ridge vent, there is a potential leakage.

Analysis: Repair is needed.

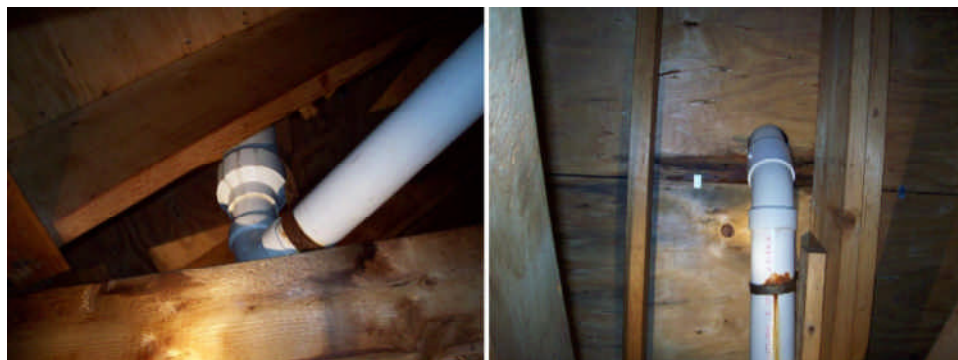
Observation: The flashing and/or the rubber gasket around the plumbing vent pipe appears to be defective.

Analysis: Repair is needed. Faulty flashing at the vent pipe / roof intersection may allow leakage. Be advised that any source of water penetration or ventilation imbalance can cause interior damage and / or mold. Note: There is a potential for concealed damage.

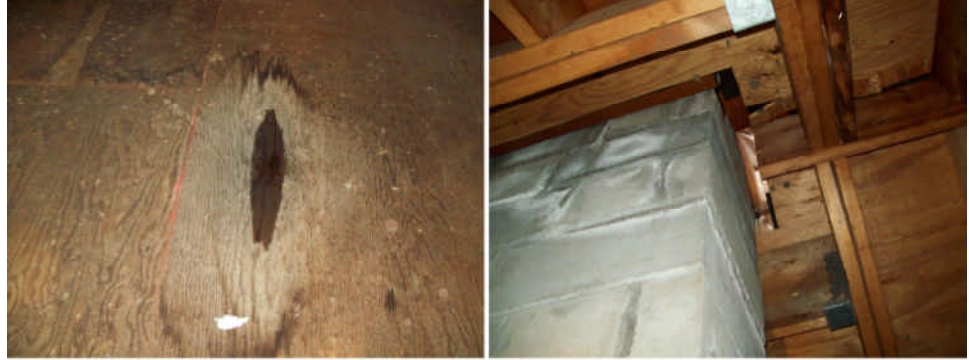
ROOF LEAKS OR AREAS OF POTENTIAL PROBLEMS:

Observation: Inspection of the roof and related components revealed a potential for leakage at the following locations:

- ** Chimney flashing.
- ** Plumbing vent pipe flashing
- ** Ridge vent.

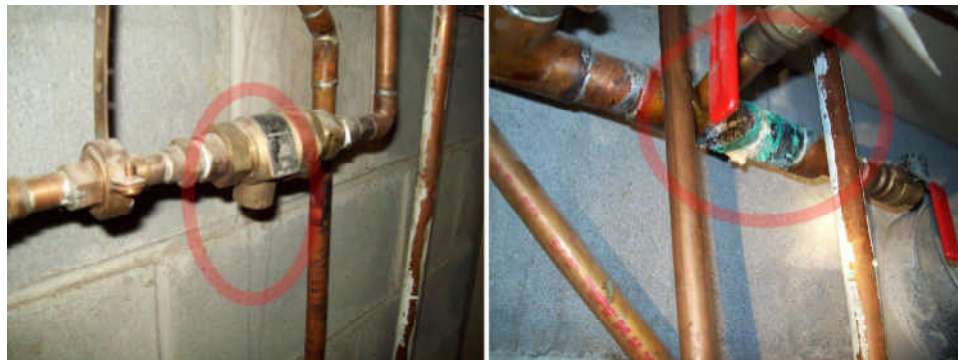
DISTRIBUTION SYSTEM PROBLEMS:

Observation: The "Air Vent" mounted on top of the "Purger Valve" at the boiler is corroded or drip leaking.

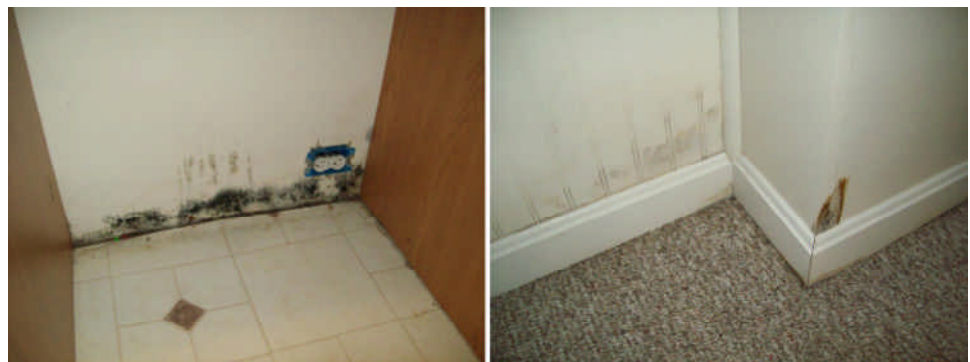
Observation: Suspected mold was visible in the home.

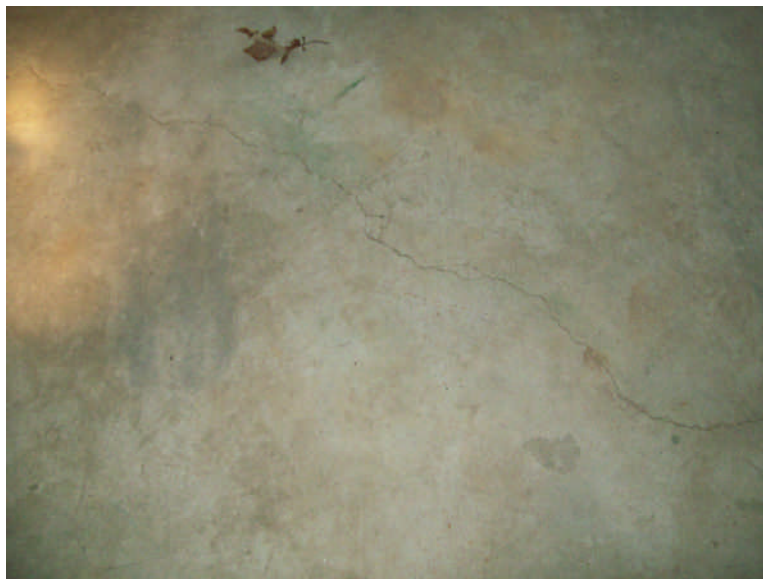
Observation: Some of the basement floor system is concealed by finished floor coverings.

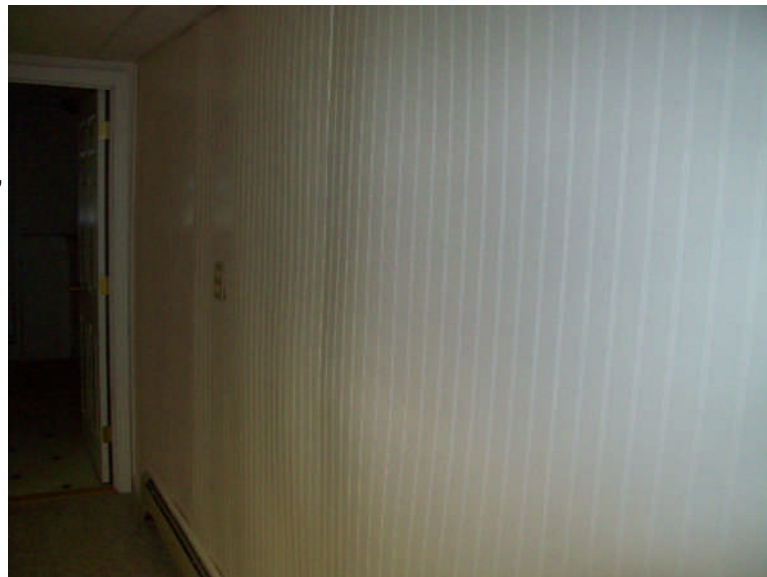
Observation: In the basement there is a finished room with paneling installed that is poorly done.

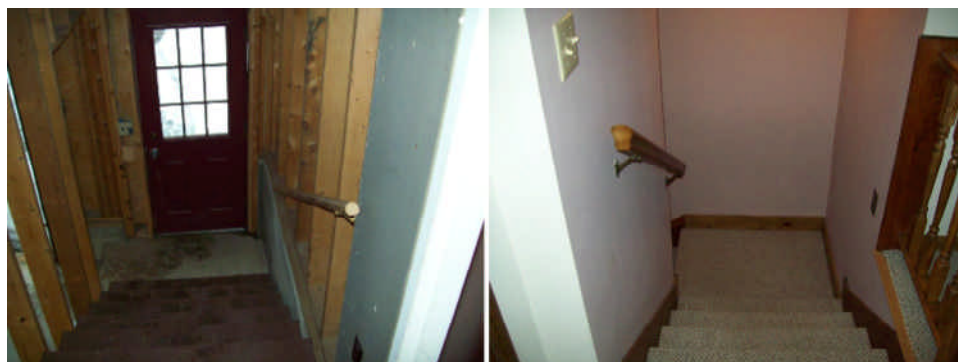
Observation: The staircase to the basement and second floor lacks returns at each end of the handrail.

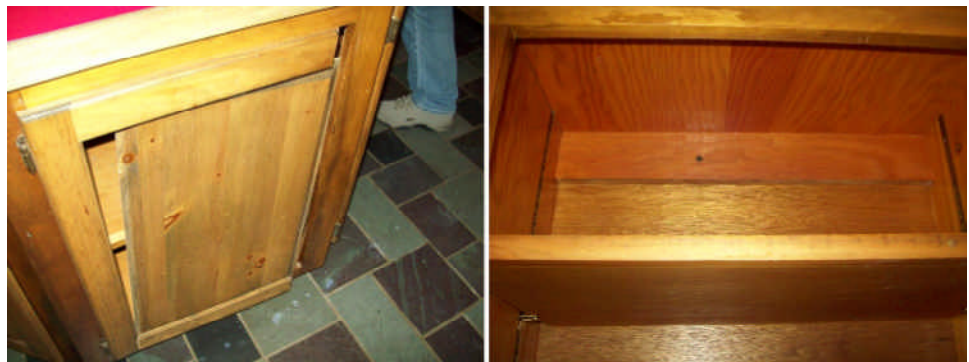
**** FUNCTIONAL with EXCEPTIONS noted:**Observation: The screws that secure the upper cabinets to the wall frame lack washers or round washer button heads.Analysis: **** **UNSAFE**, without washers or round washer button heads, the screws could pull through the thin cabinet backing under the weight of storage in the cabinets. URGENT but simple safety repair is needed. Each cabinet should have a minimum of four 3 1/2-inch round button head screws or cabinet mounting screws secured directly to the wall stud frame. Such screws have an oversize washer formed as part of the head itself, providing larger bearing and resistance to pull-out.Recommendation: Install button head screws or a washer beneath the head of each screw **NOW** for safety.Observation: Damaged cabinets are visible.Analysis: Repairs are needed.Recommendation: Ask a carpenter or cabinet supplier to re-evaluate the damaged cabinet to see if repair is feasible or if replacement is needed and cost estimates.

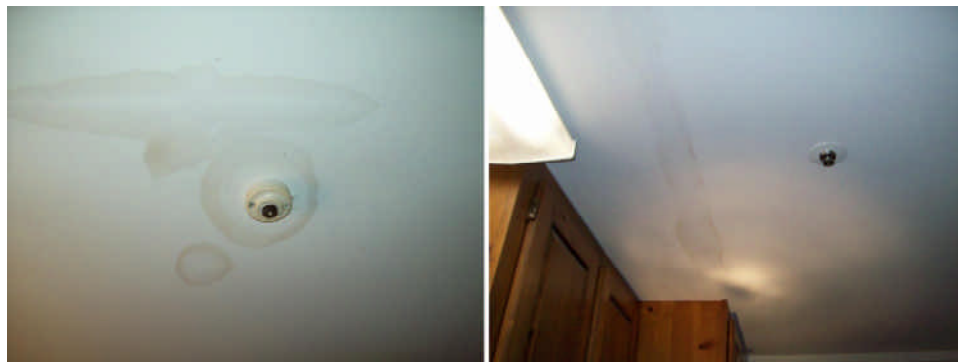
CEILING PROBLEMS:

Observation: There is a visible water stain on a ceiling.

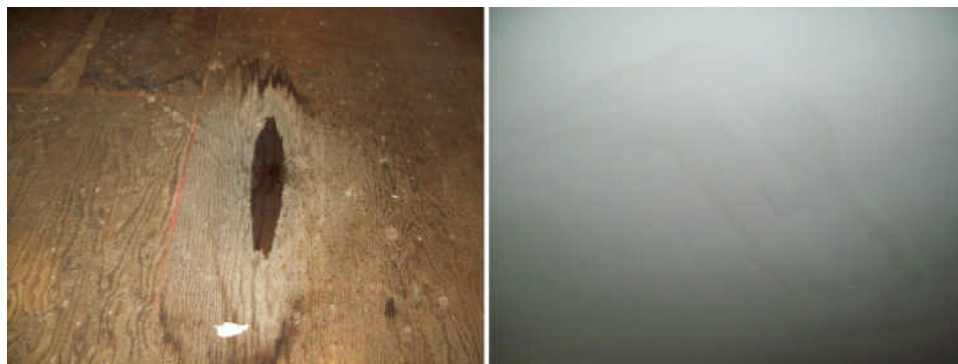
Observation: Signs of water penetration (stains) were observed on ceilings. The moisture stains tested as being dry at time of inspection.
