HVAC Air Leakage Inspections

Application Note

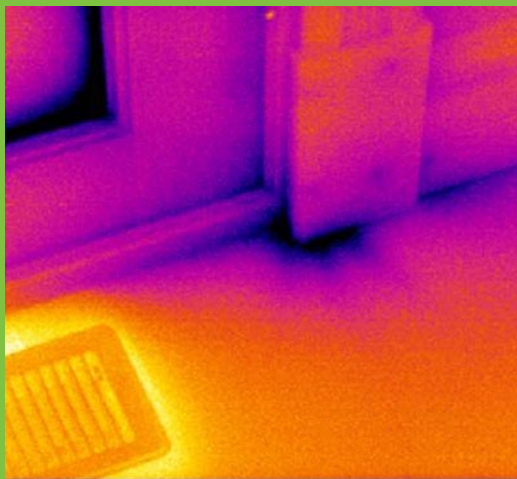
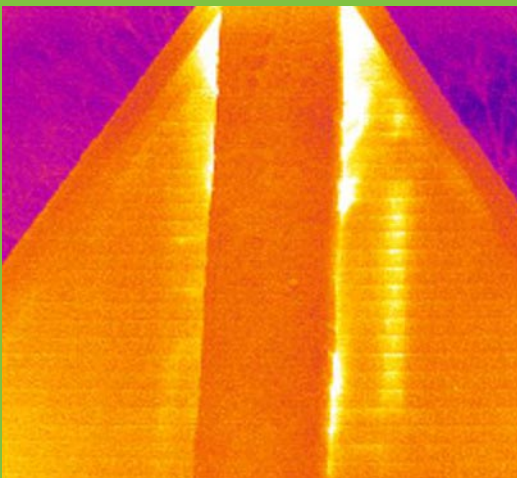
Inspecting to locate air leakage requires a 4 °F or higher temperature difference between inside and outside air, in order to get accurate readings. Air leakage can be into the building, as in the cold air shown leaking through the floor, or out of it, as in the warm air leaking out alongside the chimney. Images courtesy of Snell Infrared ©2005

In energy audits of homes and other buildings, technicians use blower doors in conjunction with thermal imagers. The blowers create positive or negative pressures within interior envelopes, making leaks much more apparent in thermal images.
