GARAGE INSPECTION

1. TYPE OF GARAGE:

Description: 2 car attached garage.

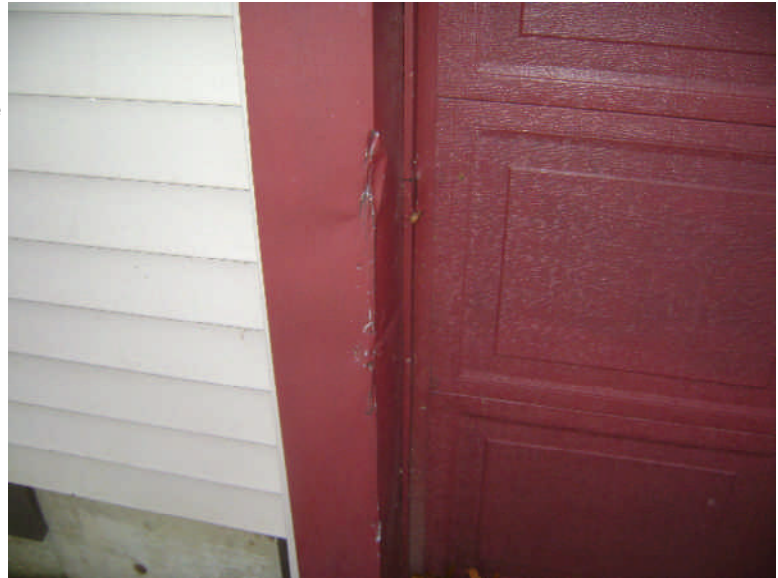
Observation: The aluminum siding outside corners are dented, damaged or loose.

Analysis: One of the disadvantages of aluminum siding and trim is that it can be easily damaged when struck. Maintenance repairs are needed.

(Note: Be advised that while repair is fairly simple for a tradesman, the availability of matching siding is undetermined.)

Recommendation: You should hire a siding contractor to remove all damaged components and to install new materials where required.
