LIVING SPACES, FIREPLACE, WOODSTOVE.

SCOPE OF THE INTERIORS SYSTEM INSPECTION: 266CMR: BOARD OF REGISTRATION OF HOME INSPECTORS

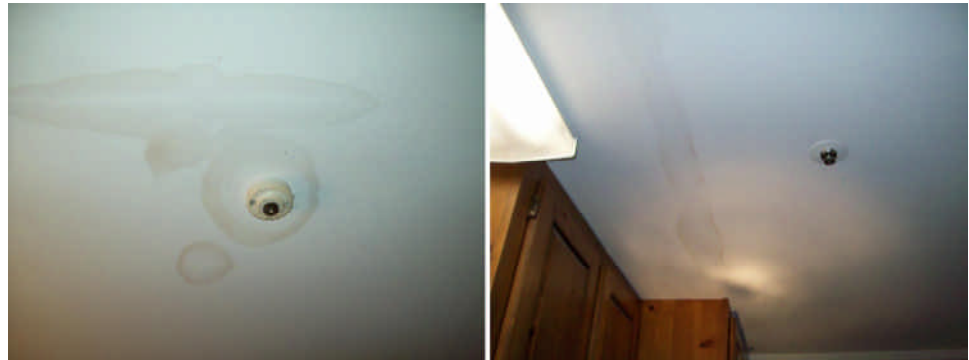
Observation: There is a visible water stain on a ceiling.

Analysis: A prior plumbing leak is suspected as the cause of the ceiling water stain.

Note: There is a potential for concealed damage. Be advised that any source of water penetration or ventilation imbalance can cause interior damage and / or mold.

Recommendation: Ask the owner to disclose any knowledge of a past leak.

Investigate and make sure that the moisture source has been correctly identified and corrected. Apply a product called stain-kills to the stained area and then re-paint the ceiling as required.

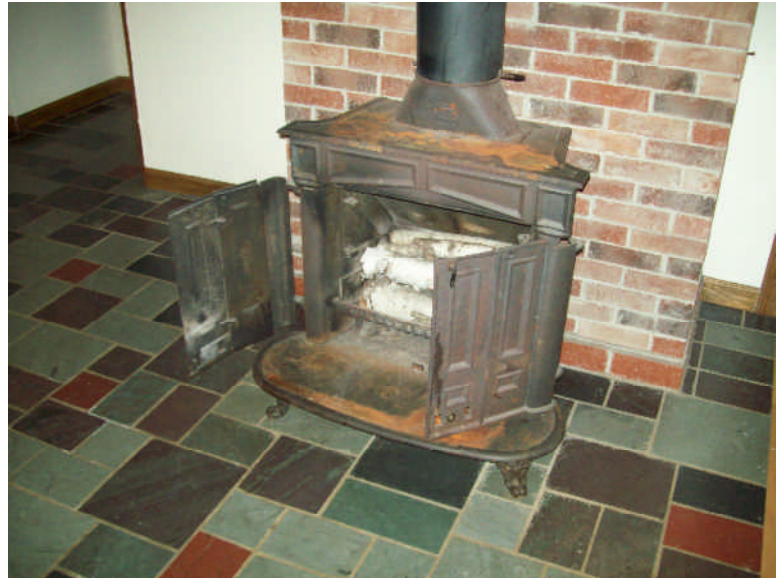
Observation: The home has a free standing wood stove.

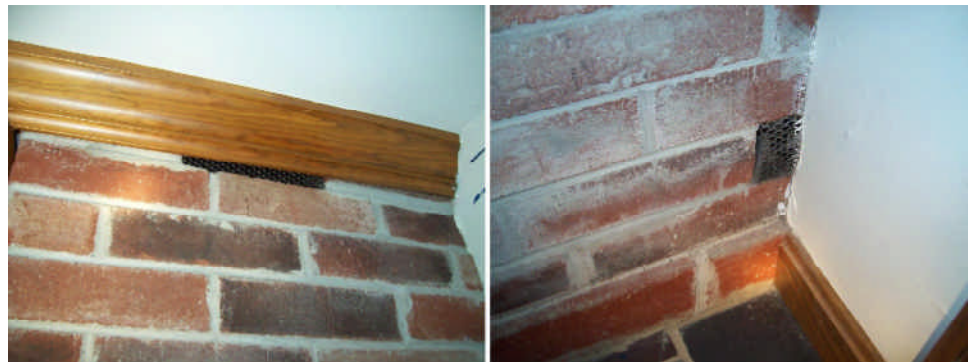
Observation: Unplugged openings are present in chimney. In the basement the insulation is not an appropriate means to plug a flue. Also in the first floor there are what appear to be vents in the brick work.

Analysis: The concern is if the flues or brick wythe have been damaged by moisture poisonous combustion gases can enter the home and cause personal injury FIRE.***
UNSAFE

Recommendation: Ask the owner if a permit is available for the stove installation. **(Permits have been required for stove installations since 1975.)** You need this documentation for insurance purposes. If the document is not available, ask the owner to request local inspection by the building or fire officials prior to purchase.

Recommendation: I advise that you hire a mason to perform safety repairs as required and have a level 2 inspection performed on the chimney liners.

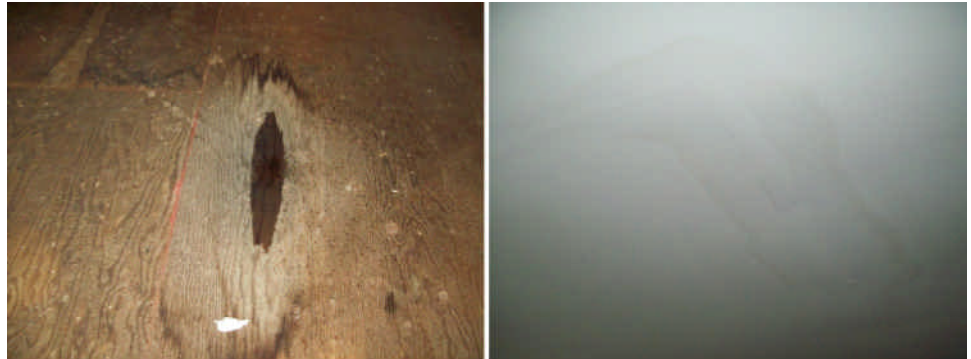
Observation: Signs of water penetration (stains) were observed on ceilings. The moisture stains tested as being dry at time of inspection.

Analysis: The above observation should NOT be considered as a guaranty against future water penetration. There is a potential for future water penetration and / or concealed damage, further investigation is needed. The source of the moisture stain may or may not have been determined during the home inspection due to the finished ceiling or systems or components that were not readily accessible. Be advised that any source of water penetration or ventilation imbalance can cause interior damage and / or mold.

Recommendation: YOU should ask the owner about the source of the ceiling stains and if the problem has been corrected. If the problem has been identified and corrected, then cosmetic ceiling repairs are needed.
