ROOF, CHIMNEY, GUTTERS INSPECTION

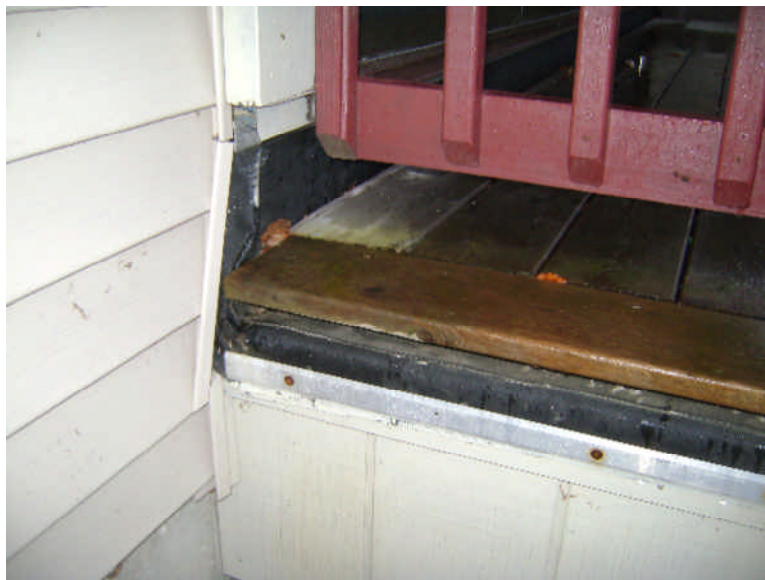
Rubber membrane roofing is present on the low sloped roof under the rear decks. (EPDM - Ethylene Propylene Diene Monomer)

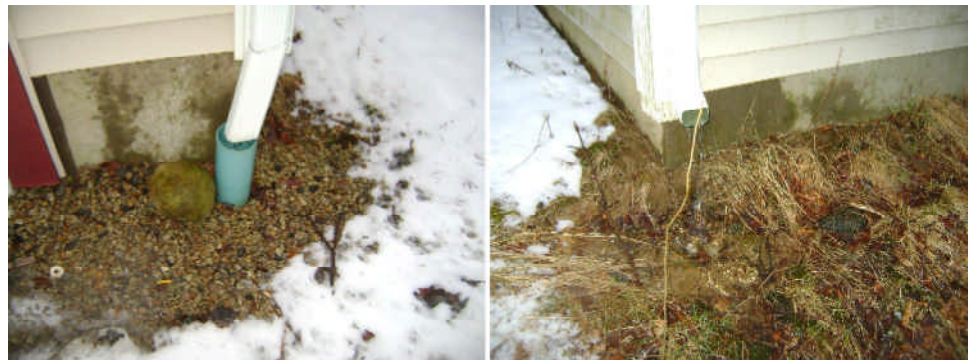
Observation: The downspouts empty roof run-off water near or adjacent to the foundation.

Analysis: Dumping excessive water near the home may cause wet basement problems, foundation problems or soil erosion. Drainage control repairs are needed NOW.

Observation: Downspouts which carry roof run-off water enter the ground near the foundation. Beyond this point, the downspouts pass underground to unknown locations.

Recommendation: I advise that each downspout be studied and corrected as required to discharge all roof drainage by gravity flow away from the building. Downspouts should have properly directed elbows, extensions and splash blocks that complement the natural grade of the property.

Recommendation: I advise that you question the owner and ask where the underground drains discharge and if they satisfactorily handle all of the water from the roof. I further advise that you monitor the drains during several seasonal periods of prolonged and heavy rains. The gutters leading to the underground drains should be screened to prevent clogging. The downspouts may empty into buried dry wells or they may run to the lot boundary or area of lower elevation. (A dry well is a covered pit with either an open jointed lining or filled with stone aggregate through which drainage from the roof seeps and leaches into the surrounding soil.) Note: Be advised that faulty downspouts that discharge near the foundation or buried drainage systems that boil over or retain water near the foundation may contribute to wet basement problems.

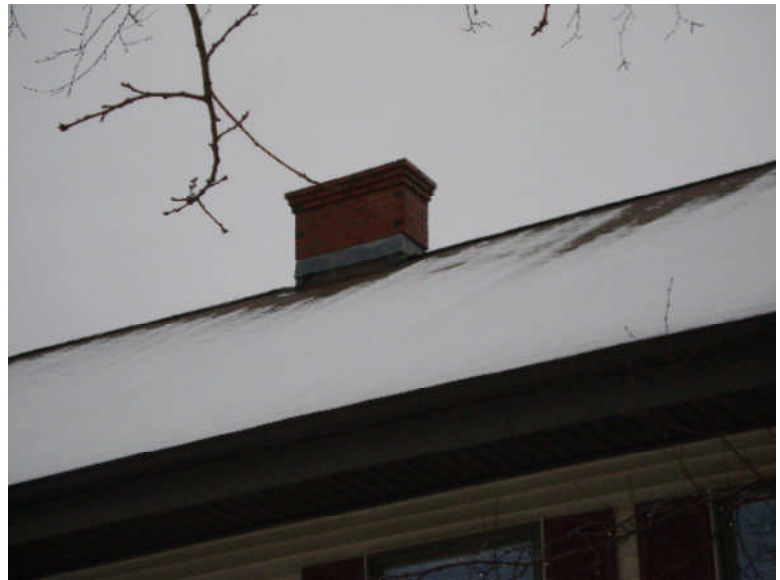
Brick chimney with multiple clay lined flues where *readily accessible* only.

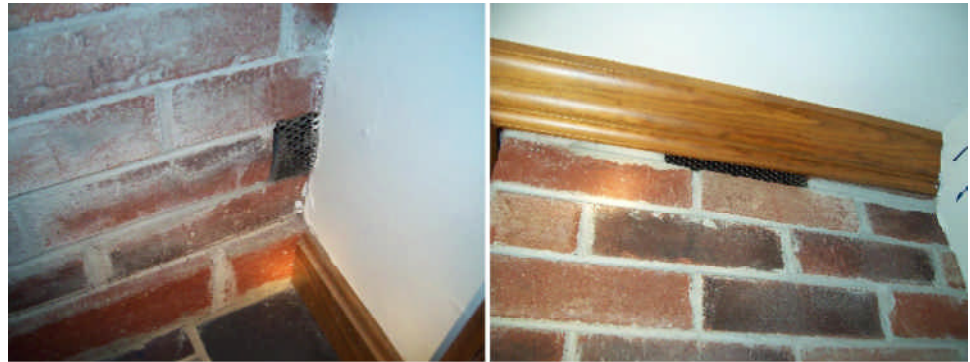
Observation: Unplugged openings are present in chimney. In the basement the insulation is not an appropriate means to plug a flue. Also in the first floor there are what appear to be vents in the brick work.

Analysis: The concern is if the flues or brick wythe have been damaged by moisture poisonous combustion gases can enter the home and cause personal injury FIRE.*** UNSAFE

Recommendation: I advise that you hire a mason to perform safety repairs as required and have a level 2 inspection preformed on the chimney liners.

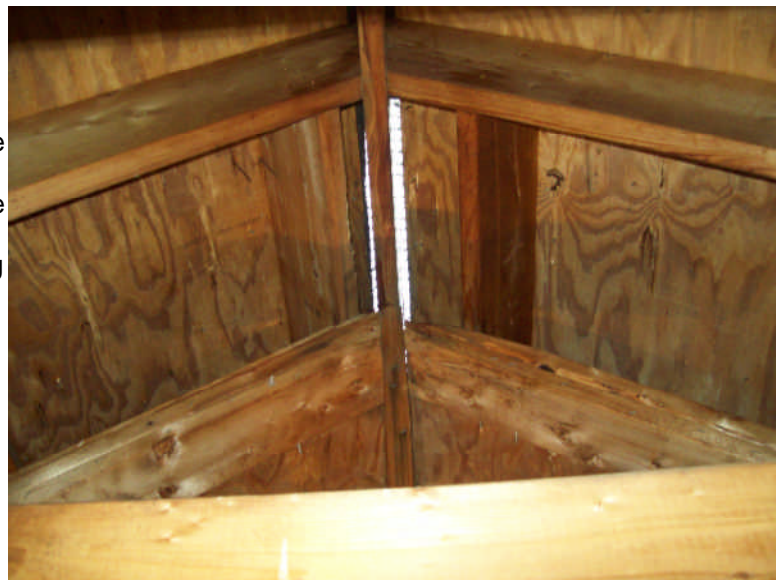
Observation: As viewed, the flashing at the intersection of the roof covering and the chimney appears to be defective. As seen from the attic I can see day light.

Analysis: The flashing needs further investigation and repair or replacement to prevent leakage and interior water damage.

Recommendation: You should ask a tradesman relative to this area of concern to further investigate the flashing and to provide a cost estimate for repairs.

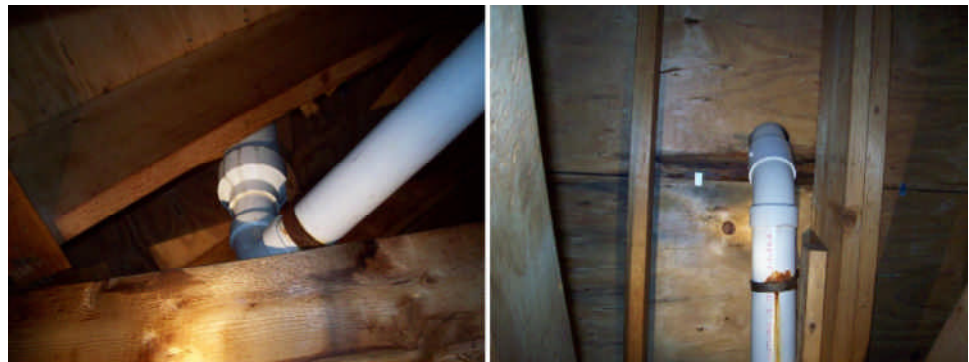
Observation: The flashing and/or the rubber gasket around the plumbing vent pipe appears to be defective.

Analysis: Repair is needed. Faulty flashing at the vent pipe / roof intersection may allow leakage. Be advised that any source of water penetration or ventilation imbalance can cause interior damage and / or mold. Note: There is a potential for concealed damage.

Observation: As viewed, the flashing at the intersection of the roof covering and the chimney appears to be defective.

Analysis: The flashing needs further investigation and repair or replacement to prevent leakage and interior water damage. Be advised that any source of water penetration or ventilation imbalance can cause interior damage and / or mold. Note: There is a potential for concealed damage.

Recommendation: Hire a roofer to perform repairs.

Recommendation: You should ask a tradesman relative to this area of concern to further investigate the flashing and to provide a cost estimate for repairs.

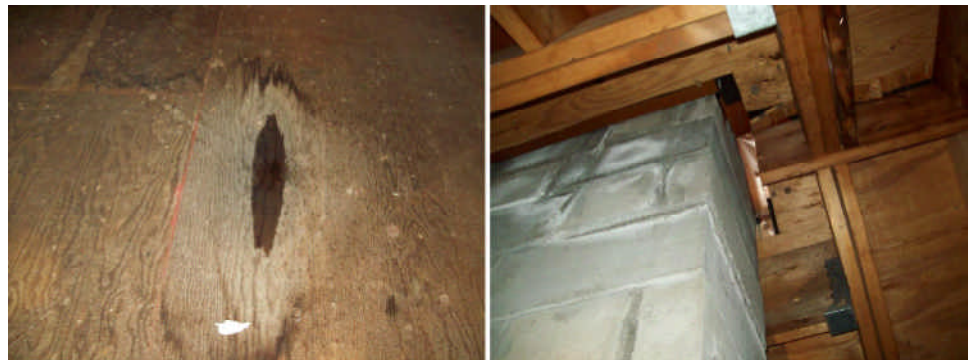
Observation: Inspection of the roof and related components revealed a potential for leakage at the following locations:

- ** Chimney flashing.
- ** Plumbing vent pipe flashing
- ** Ridge vent.

Analysis: Defects in any of the above roof components may allow leakage, interior

water damage and mold. Note: There is a potential for concealed damage.

Recommendation: Prior to commitment, you should ask a roofer to perform an on-roof inspection of all components and to provide an estimate for repair or replacement as required to restore function.
