Seacoast Inspections LLC
263 Winnacunnet Rd,
Hampton, NH 03842
603-783-1679

FINAL NARRATIVE REPORT

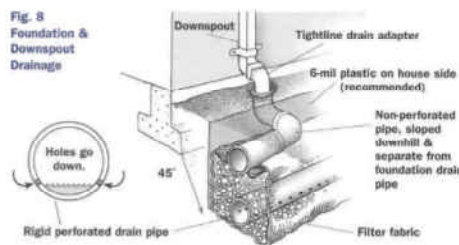
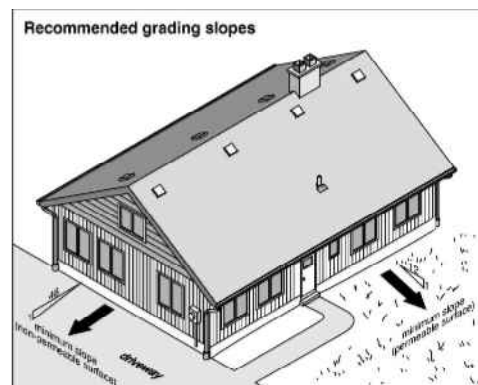
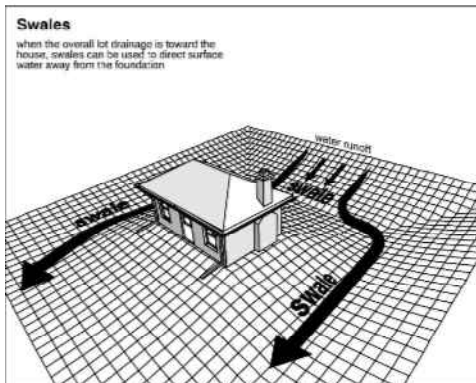
1. GRADING & SITE DRAINAGE:

Observation: At the time of inspection, there was snow on the property.

Analysis: The home inspection is limited in scope and nature to only those areas that are *readily accessible* at the time of inspection. Be advised that the snow may conceal exterior defects that the inspector could not view.

Recommendation: **You should discuss this problem with your attorney NOW prior to agreement to purchase the property. All snow covered components should be listed in the contract of sale and should be guaranteed by the owner to be serviceable and operative.** All snow covered areas require further investigation during the first thaw. If your research reveals any major concerns, you should contact my office for further consultation or schedule an optional "return visit inspection."

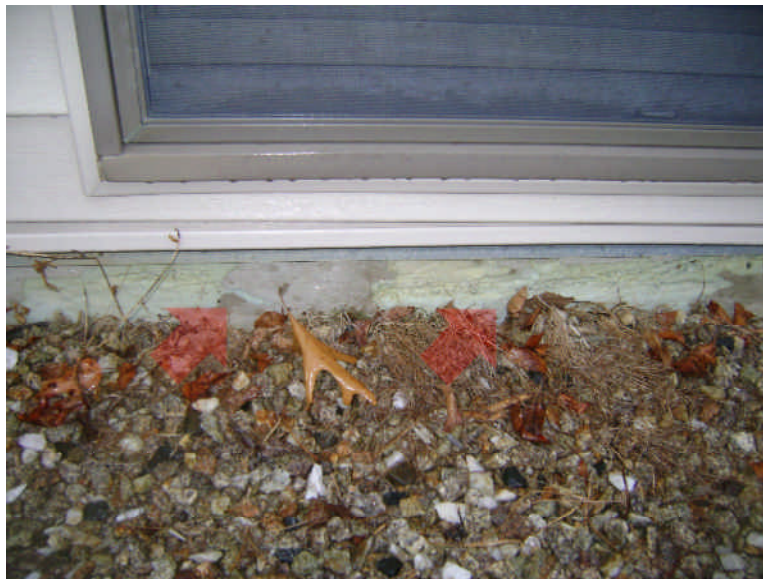
Analysis: The insulation board prevented any inspection of the exterior of the foundation. The insulation board is damaged and was never properly protected. This will break down from exposure to UV rays. Also this type of installation is conducive to pest infestation. Carpenter ants love to nest in it and termites can enter the house behind it without ever being seen.

Recommendation: I would cut it back to ground level and expose the foundation for visual inspection. This way in the future you can monitor and visually see if any pest infestation could be taking place.

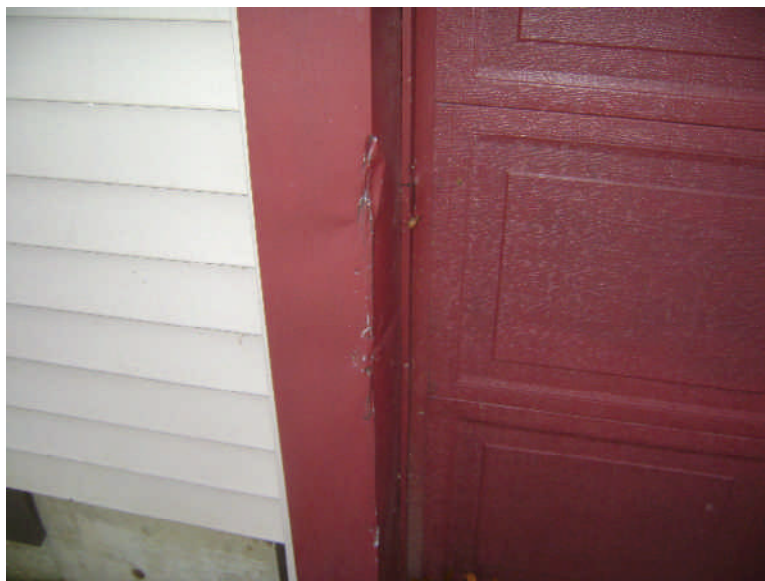
repairs are needed. (Note: Be advised that while repair is fairly simple for a tradesman, the availability of matching siding is undetermined.)

Recommendation: You should hire a siding contractor to remove all damaged components and to install new materials where required.

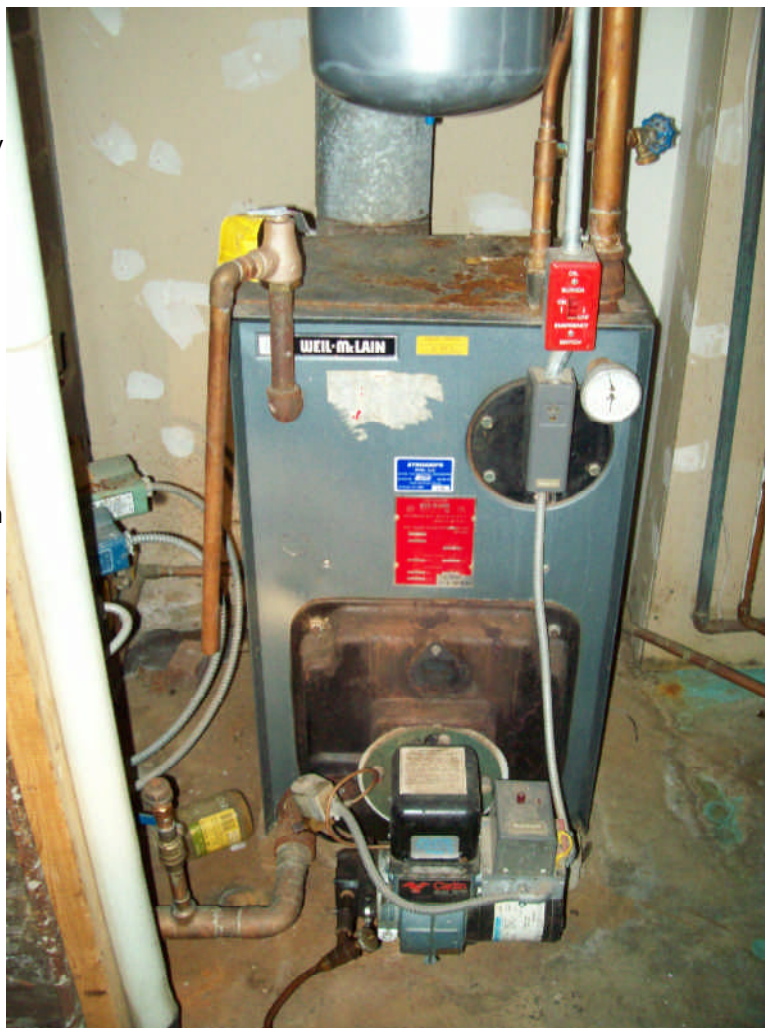
Analysis: The lack of maintenance tags may indicate postponed annual maintenance cleanings, tune-ups, parts replacement and safety inspection.

Recommendation: Ask the owner when the system was last serviced. You should have the heating system serviced upon occupancy to establish a good annual service schedule.

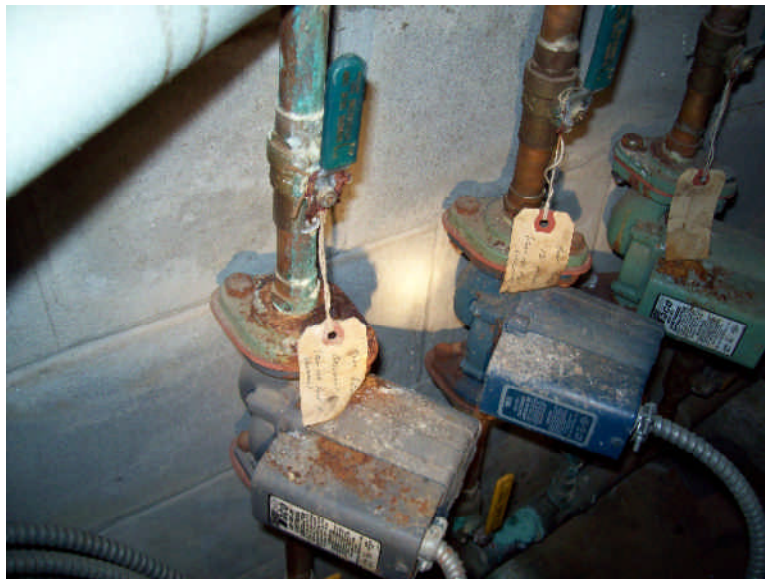
Analysis: Maintenance repair is needed.

Recommendation: Hire a heating contractor to perform maintenance repairs as needed to stop the leak.

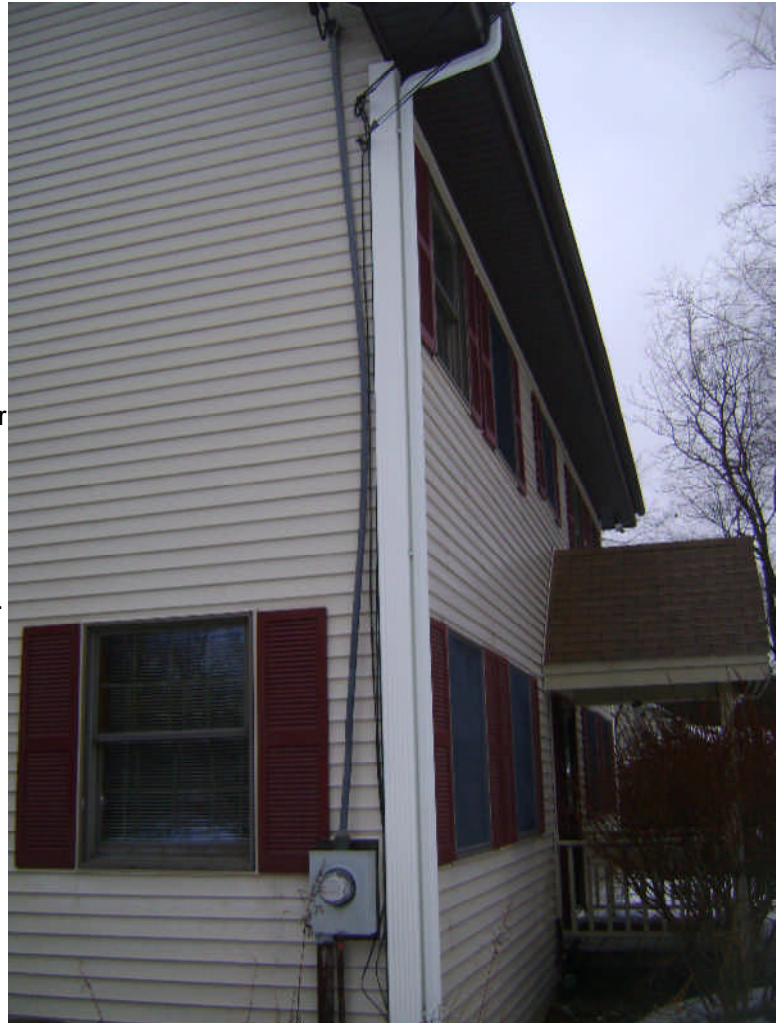
Analysis: While an exposed insulated cable is acceptable, enclosure in a metal or plastic raceway offers greater protection against cable deterioration caused by exposure to the elements and sunlight.

Recommendation: Monitor the cable for future fraying and have it replaced by an electrician as a frayed service cable may allow water infiltration. You should paint the cable to prevent fraying and maintain all waterproof connections with dux-seal.

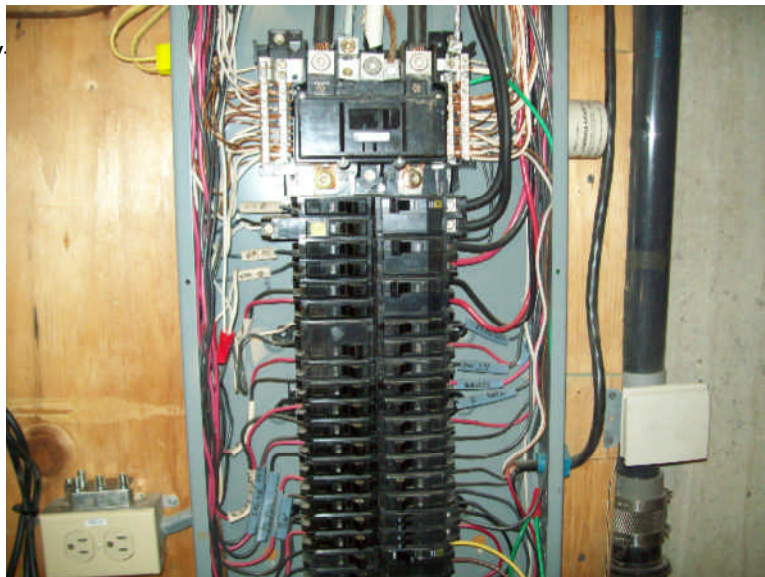
Analysis: Breakers of this type are not to be used unless the panel is designed for them. Often such breakers are installed when space in the panel is limited, and no one wants to pay an electrician to install a larger panel or a subpanel. The mini-breakers may exceed the number of circuits in the panel specified by the panel manufacturer.

Recommendation: Further investigation by an electrician is advised. A larger panel may be needed.

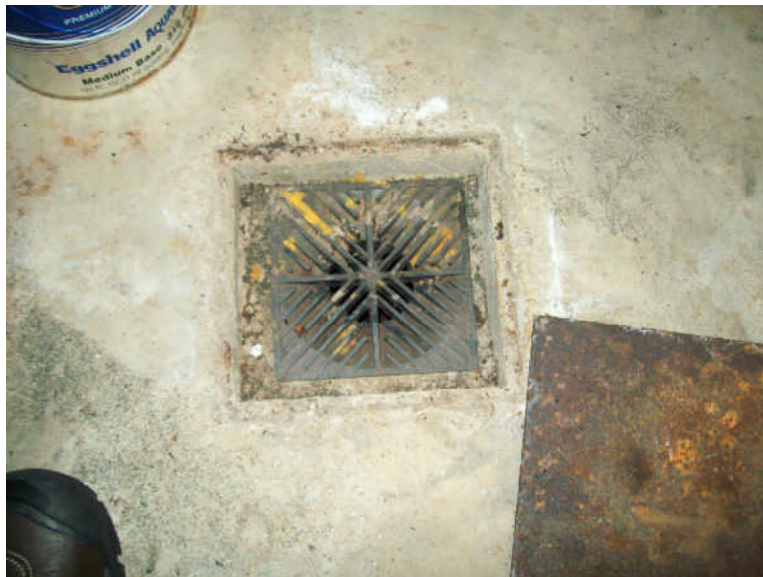
Analysis: The true function, seasonal need and discharge point of the drain are undetermined.

Recommendation:
Ask the owner where the drain discharges and how often it is needed. (Cleaning & testing for drainage is advised.)

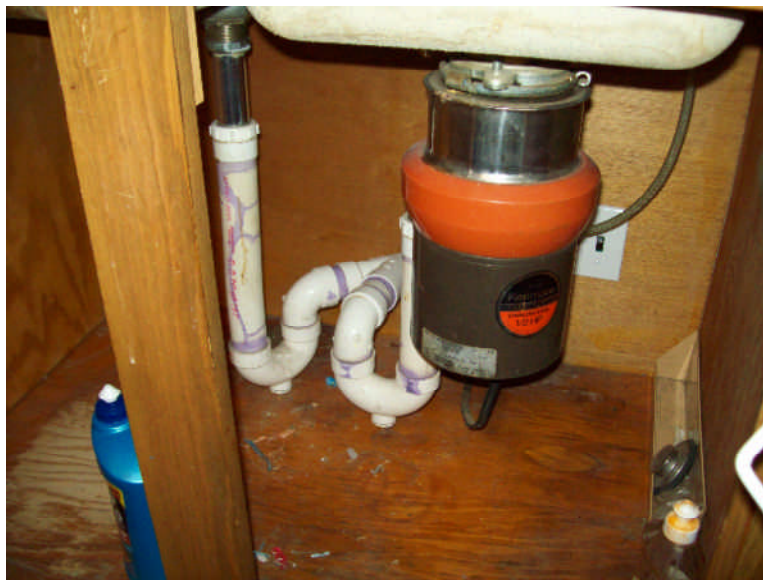
Analysis: Be advised that a garbage disposer is not recommended with a private waste disposal system as the future function of the waste disposal system may be diminished, impaired or damaged.

Recommendation: I advise that you have the garbage disposer removed.
