# Moisture in building envelopes

## Application Note

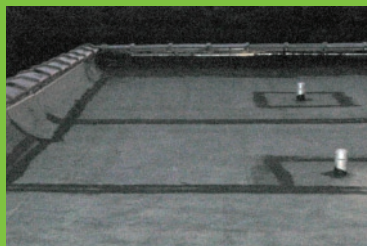
Cool areas on this roof exposure probably indicate moisture buildup. Mark with tape and investigate with core samples.
