## KITCHEN INSPECTION

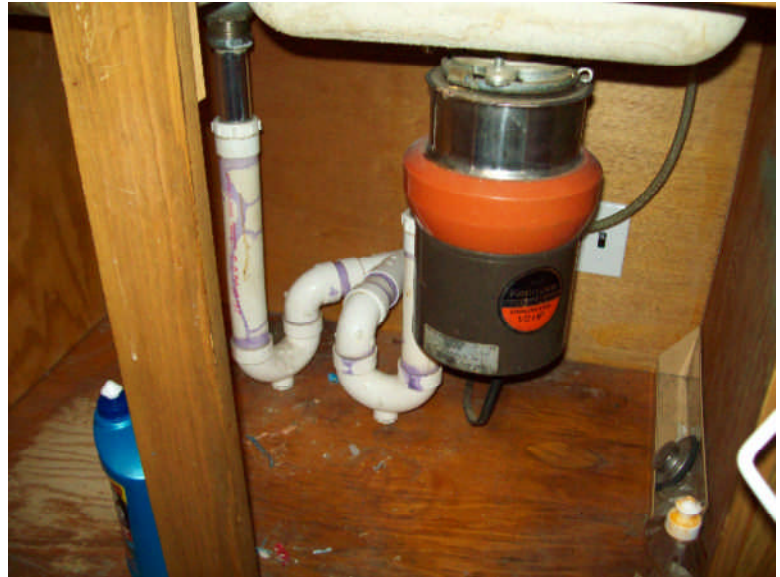
Observation: The home has a garbage disposer and a private waste disposal system.

Analysis: Be advised that a garbage disposer is not recommended with a private waste disposal system as the future function of the waste disposal system may be diminished, impaired or damaged.

Recommendation: I advise that you have the garbage disposer removed.

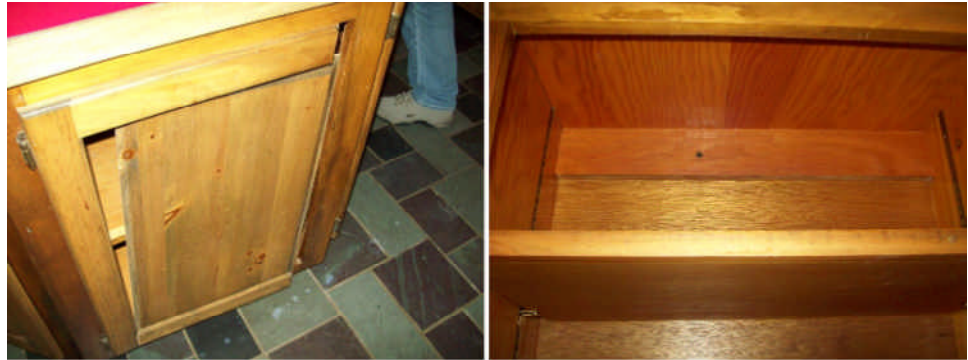
**6. CABINETS:****CONDITION:**

Observation: The screws that secure the upper cabinets to the wall frame lack washers or round washer button heads.

Analysis: \*\*\*\* **UNSAFE**, without washers or round washer button heads, the screws could pull through the thin cabinet backing under the weight of storage in the cabinets. URGENT but simple safety repair is needed. Each cabinet should have a minimum of four 3 1/2-inch round button head screws or cabinet mounting screws secured directly to the wall stud frame. Such screws have an oversize washer formed as part of the head itself, providing larger bearing and resistance to pull-out.

Observation: Damaged cabinets are visible.

Analysis: Repairs are needed.

Recommendation: Install button head screws or a washer beneath the head of each screw **NOW** for safety.

Recommendation: Ask a carpenter or cabinet supplier to re-evaluate the damaged cabinet to see if repair is feasible or if replacement is needed and cost estimates.

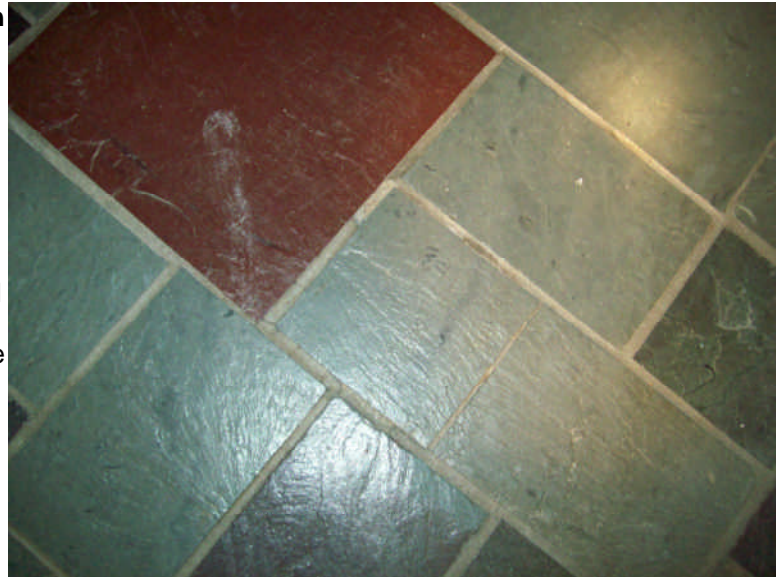
Observation: Cracked ceramic tiles or loose grout are visible at the kitchen floor.

**UNSAFE.** Ceramic floor tiles do not tolerate floor frame movement and crack accordingly.

**WARNING - sharp edges can cause personal injury.**

Recommendation: Ask the owner if any extra tiles are in storage. Hire a tile contractor to perform repairs or replacement as required. Note: You may be wise to reinforce the floor joists to reduce movement and future cracked tiles.
