## PLUMBING & HOT WATER HEATER INSPECTION

### SCOPE OF THE PLUMBING INSPECTION: 266CMR: BOARD OF REGISTRATION OF HOME INSPECTORS 266 CMR 6.00: STANDARDS OF PRACTICE:

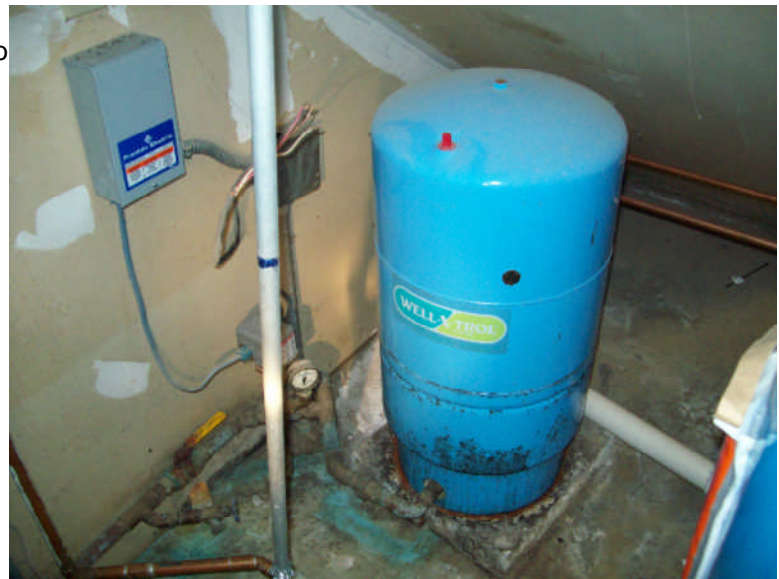
The main shut-off valve is located next to the pressure tank in the basement.

\* **FUNCTIONAL** where *readily accessible* at time of inspection. **NOTICE:** Be advised that the main water shut-off valve was not tested during the home inspection and that its true operational condition is undetermined. The valve was not tested as the inspector would be liable for breakage, leakage or loss of water. Further investigation and testing are needed by YOU or by a plumber.

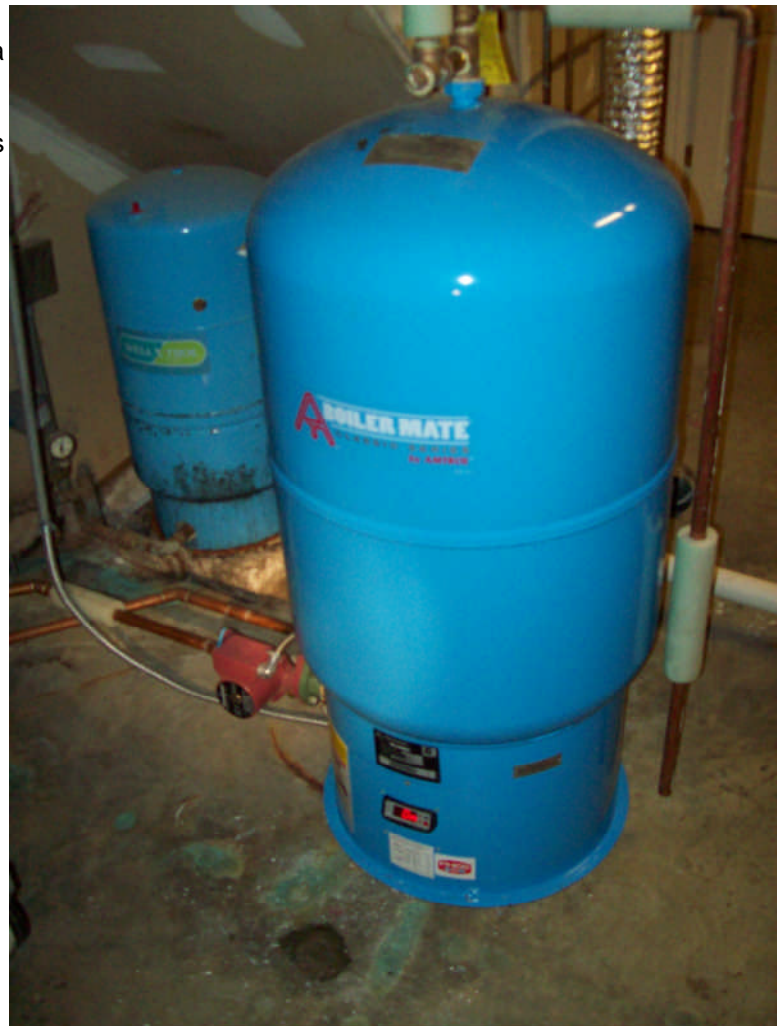
Observation: The hot water is produced by a **COMPANION** storage tank attached to the heating boiler. (This is a modern state-of-the-art type of hot water production.)

40 gallons capacity.

Observation: The age of the water heater is unknown.

\* **FUNCTIONAL.** Hot water was available at each fixture serviced. The required automatic safety devices (shut-off valve, temperature/pressure relief valve and vacuum relief valve) are present and appear visually **FUNCTIONAL** as designed to protect the hot water systems & components from excessively high or low pressures & temperatures, excessive electrical current, loss of water, loss of ignition, fuel leaks, fire, freezing, or other unsafe conditions. (Controls are NOT tested.)

Recommendation: Further research advised. Ask the owner how old the water heater is.

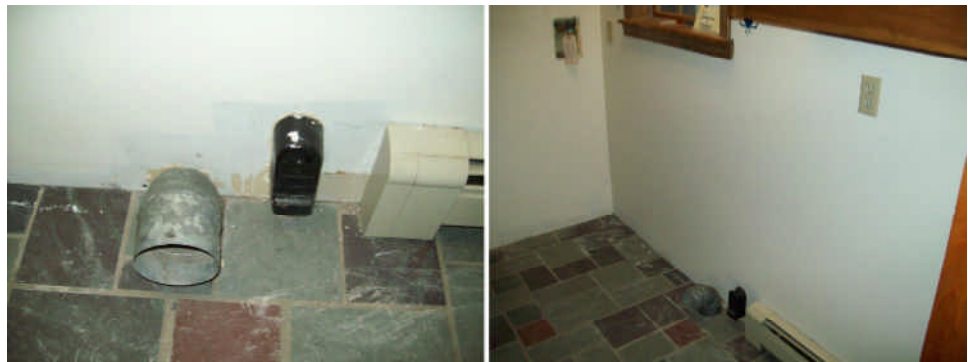
\*\* Observation: Laundry facilities are **FUNCTIONAL** with exceptions noted:

Observation: While previously allowed, the receptacle provided for the electric dryer is an older style with three holes for a 3 prong plug that does not provide modern grounding.

Analysis: Be advised that the dryer circuits in new homes must now be wired with a four wire conductor cable feeding a four hole outlet to mate with a four prong dryer plug for added grounding safety. The receptacle must have four holes and the dryer cord (pigtail) must have four prongs to mate properly.

Observation: The washing machine is installed level with or above living space and a protective safe pan is missing beneath the appliance.

Analysis: Without a safe pan under the washing machine, there is a potential for interior water damage if leakage occurs.

Recommendation: For safety, I advise that you hire an electrician to upgrade the dryer circuit wire, the dryer outlet and the appliance cord for modern grounding safety.

Recommendation: The installation of a safe pan with a drain is advised. Consult a plumber.
